HA8000V シリーズ

Service Pack for HA8000V (SPH)

Version 12.02 10

Readme

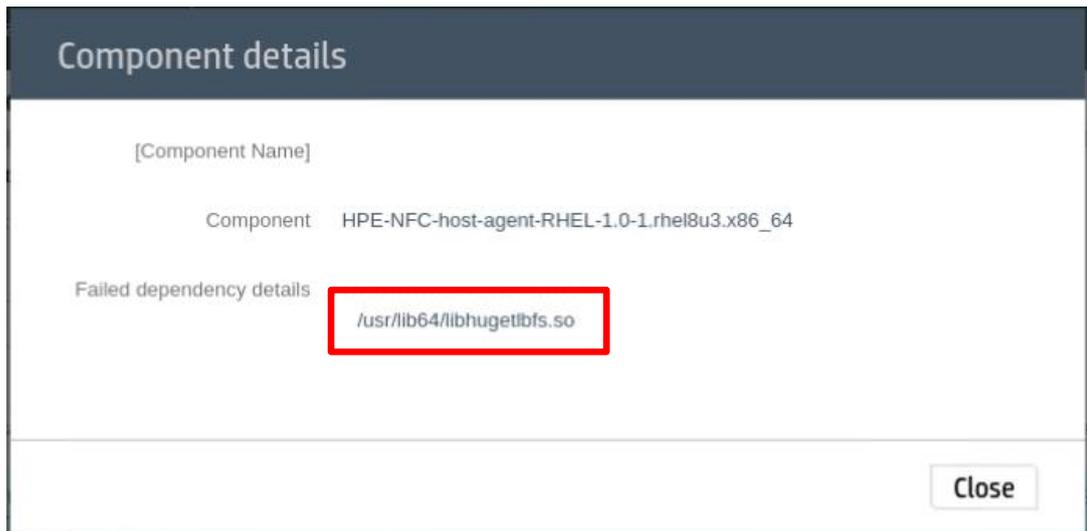
上記赤枠内の赤丸をダブルクリックすると次のダイアログが表示され、“Failed dependency details”として、インストールが必要となるファイル/ライブラリが表示されます。(赤枠内)

上記の例では、インストールが必要となるファイル/ライブラリとして、“libhugetlbfs.so”を示しています。

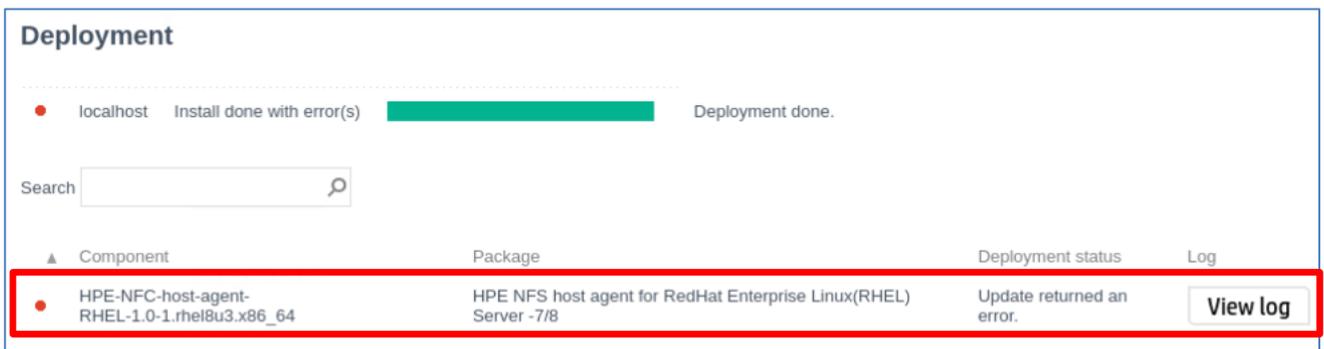
エラーが発生したパッケージは、赤丸(赤枠内)で表示されます。

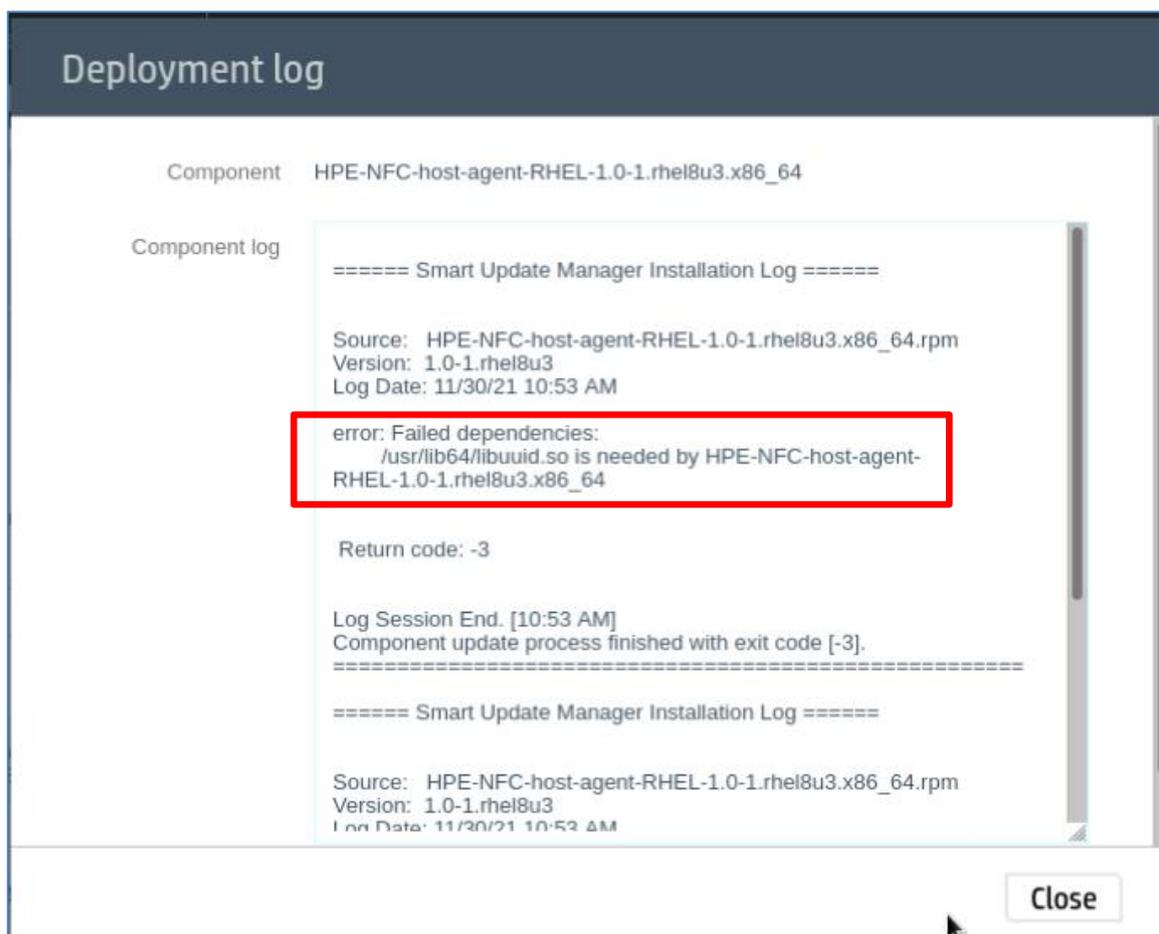
上記赤枠内の“View log”をクリックすると次のダイアログが表示され、“error: Failed dependencies:”として、インストールが必要となるファイル/ライブラリが表示されます。(赤枠内)

上記の例では、インストールが必要となるファイル/ライブラリとして、“libuuid.so”を示しています。

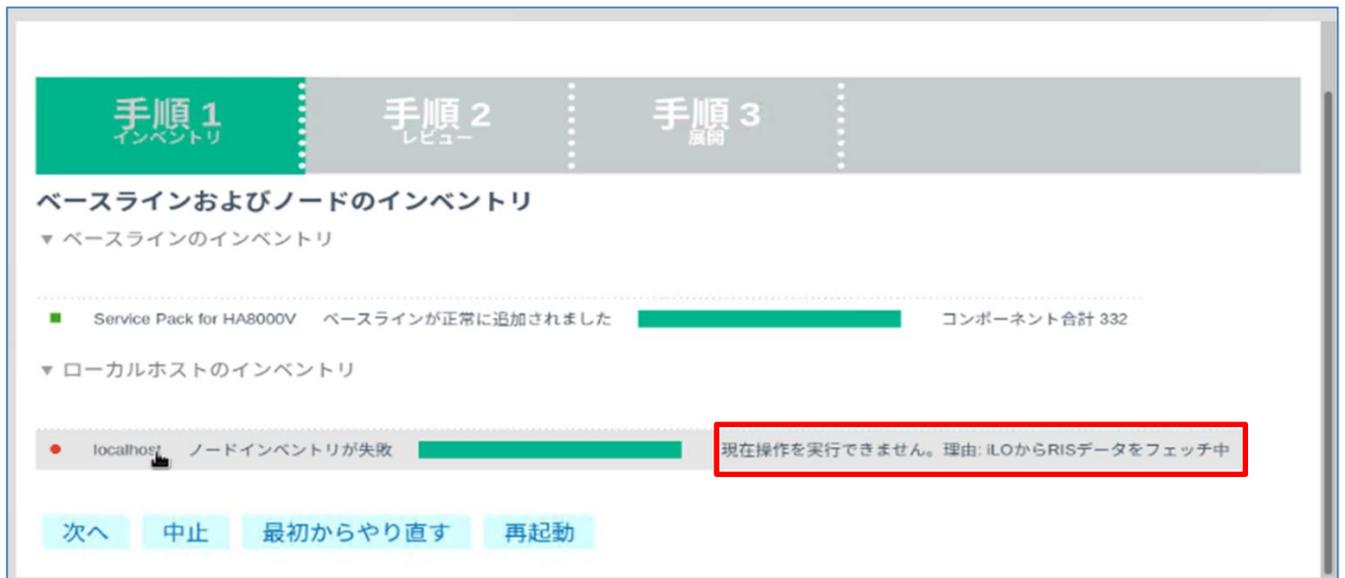
【インベントリ失敗時の表示例】

iLO の状態により、まれに情報取得できないことがあり、以下に示すようにインベントリに失敗します。

SUM を再実行しても本エラーが解消されない場合は、下記のいずれかの手順を実施してください。

- iLO の再起動（リセット）を実施してください。詳細は『iLO 7 x.xx ユーザーガイド』（※）の「iLO の再起動（リセット）」を参照してください。『iLO 7 x.xx ユーザーガイド』は、「[日立アドバンスドサーバ HA8000V シリーズ ホームページ](#)」に掲載されている「製品マニュアル」よりダウンロードしてください。
- オンラインアップデート(OS 稼働中のアップデート)の場合、装置の再起動を実施してください。
- 装置の給電を停止(電源ケーブルの抜去や UPS の出力停止等)後、10 秒待った後に給電を再開してください。
