HA8000V シリーズ

Service Pack for HA8000V (SPH)

Version 6.30 35

Readme

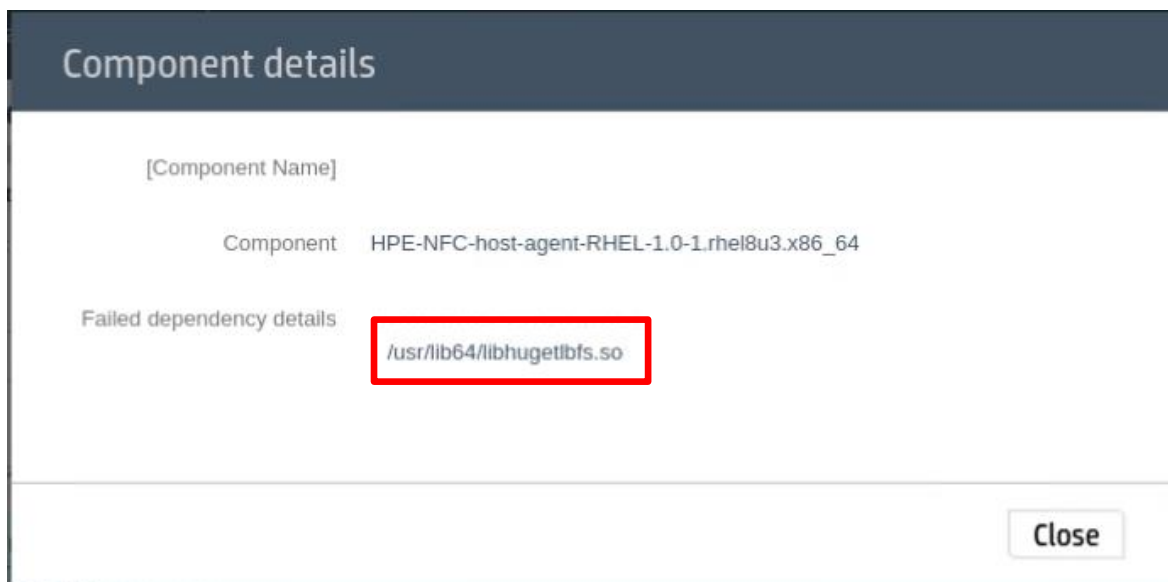
上記赤枠内の赤丸をダブルクリックすると次のダイアログが表示され、“Failed dependency details”として、インストールが必要となるファイル/ライブラリが表示されます。(赤枠内)

上記の例では、インストールが必要となるファイル/ライブラリとして、“libhugetlbfs.so”を示しています。

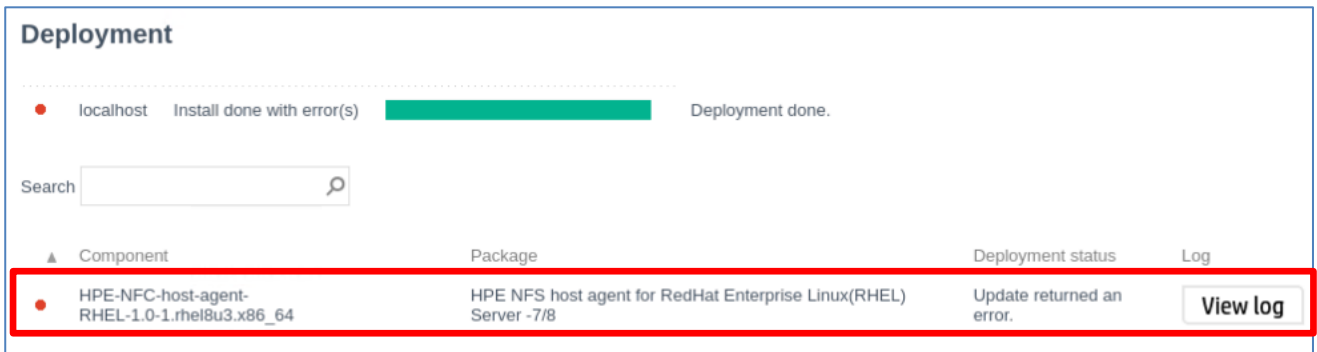
エラーが発生したパッケージは、赤丸(赤枠内)で表示されます。

Component	Package	Deployment status	Log
HPE-NFC-host-agent-RHEL-1.0-1.rhel8u3.x86_64	HPE NFS host agent for RedHat Enterprise Linux(RHEL) Server -7/8	Update returned an error.	View log

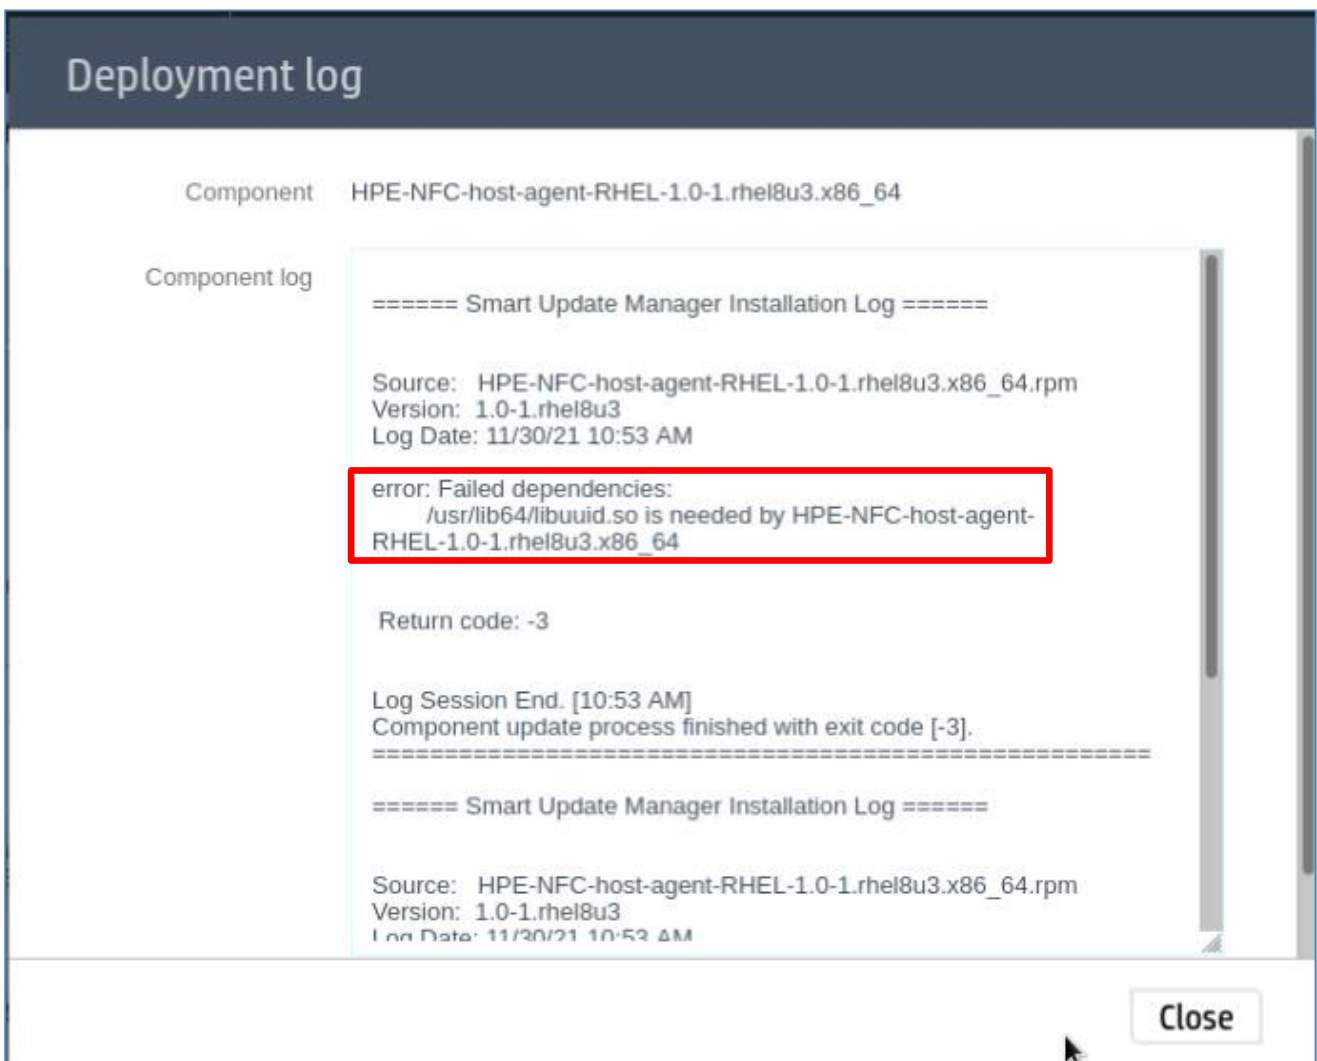
上記赤枠内の“View log”をクリックすると次のダイアログが表示され、“error: Failed dependencies:”として、インストールが必要となるファイル/ライブラリが表示されます。(赤枠内)

```
=====  
Smart Update Manager Installation Log  
=====  
Source: HPE-NFC-host-agent-RHEL-1.0-1.rhel8u3.x86_64.rpm  
Version: 1.0-1.rhel8u3  
Log Date: 11/30/21 10:53 AM  
error: Failed dependencies:  
  /usr/lib64/libuuid.so is needed by HPE-NFC-host-agent-  
  RHEL-1.0-1.rhel8u3.x86_64  
Return code: -3  
Log Session End. [10:53 AM]  
Component update process finished with exit code [-3].  
=====  
=====  
Smart Update Manager Installation Log  
=====  
Source: HPE-NFC-host-agent-RHEL-1.0-1.rhel8u3.x86_64.rpm  
Version: 1.0-1.rhel8u3  
Log Date: 11/30/21 10:53 AM
```
