HA8000V シリーズ

Service Pack for HA8000V (SPH)

Version 7.40 12

Readme

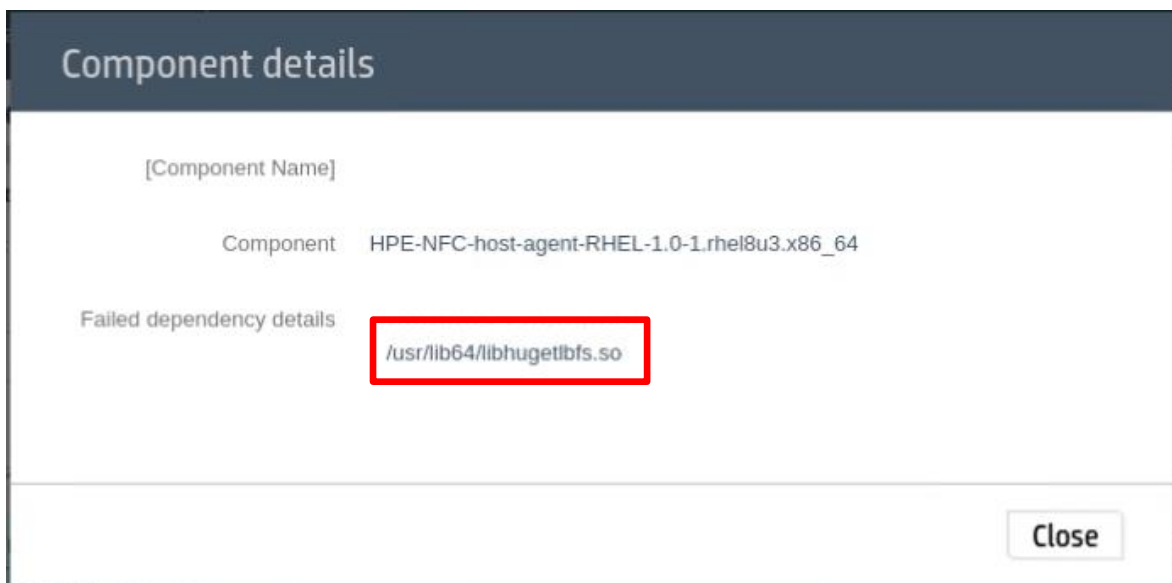
上記赤枠内の赤丸をダブルクリックすると次のダイアログが表示され、“Failed dependency details”として、インストールが必要となるファイル/ライブラリが表示されます。(赤枠内)

上記の例では、インストールが必要となるファイル/ライブラリとして、“libhugetlbfs.so”を示しています。

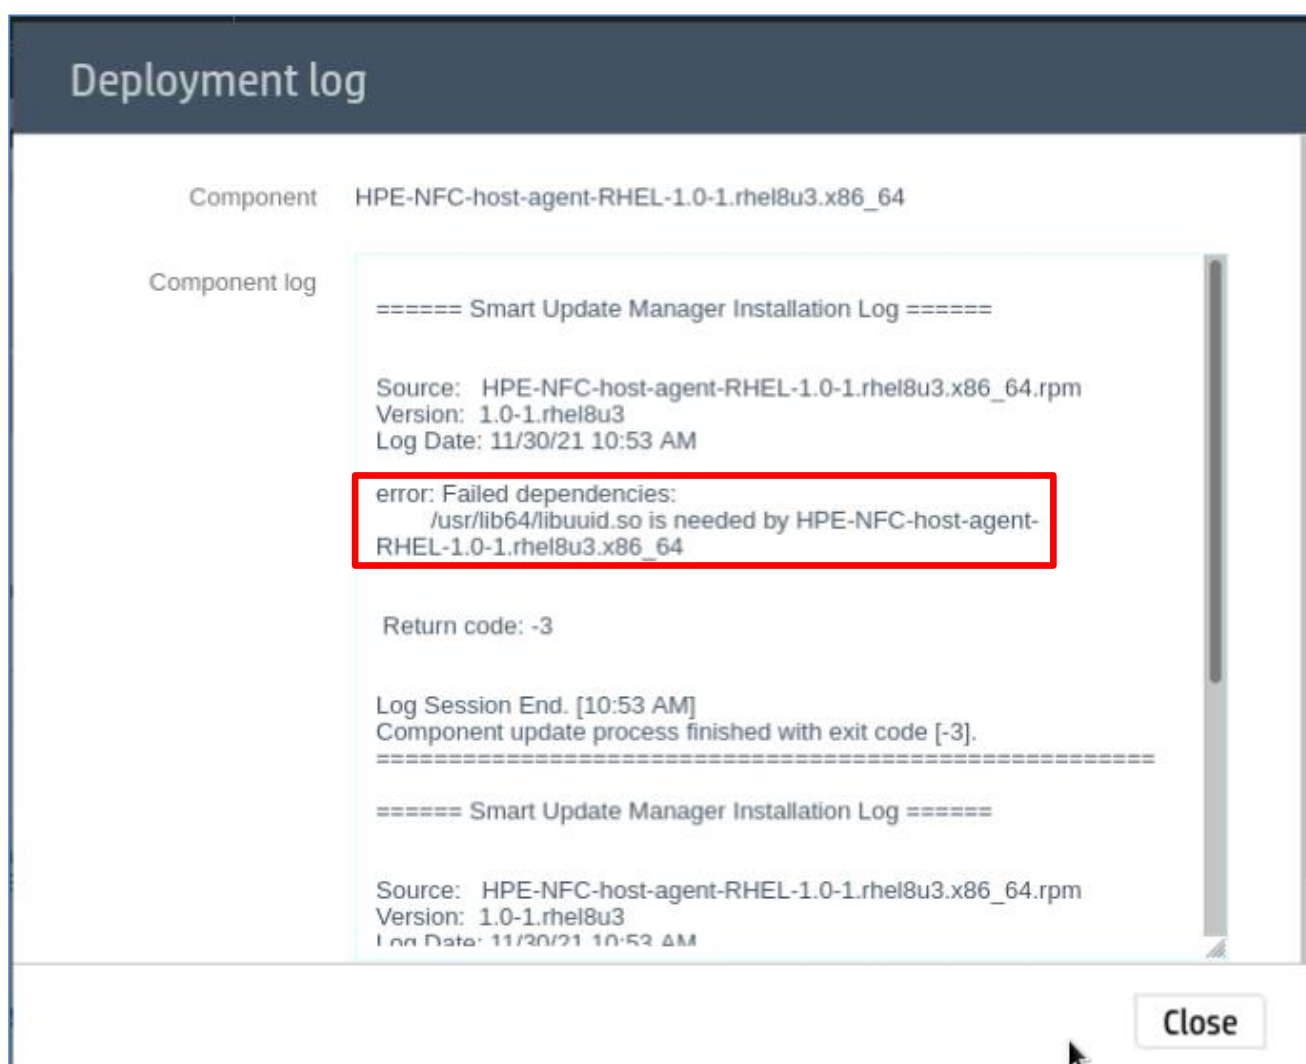
上記赤枠内の“View log”をクリックすると次のダイアログが表示され、“error: Failed dependencies:”として、インストールが必要となるファイル/ライブラリが表示されます。(赤枠内)

error: Failed dependencies:
/usr/lib64/libuuid.so is needed by HPE-NFC-host-agent-
RHEL-1.0-1.rhel8u3.x86_64

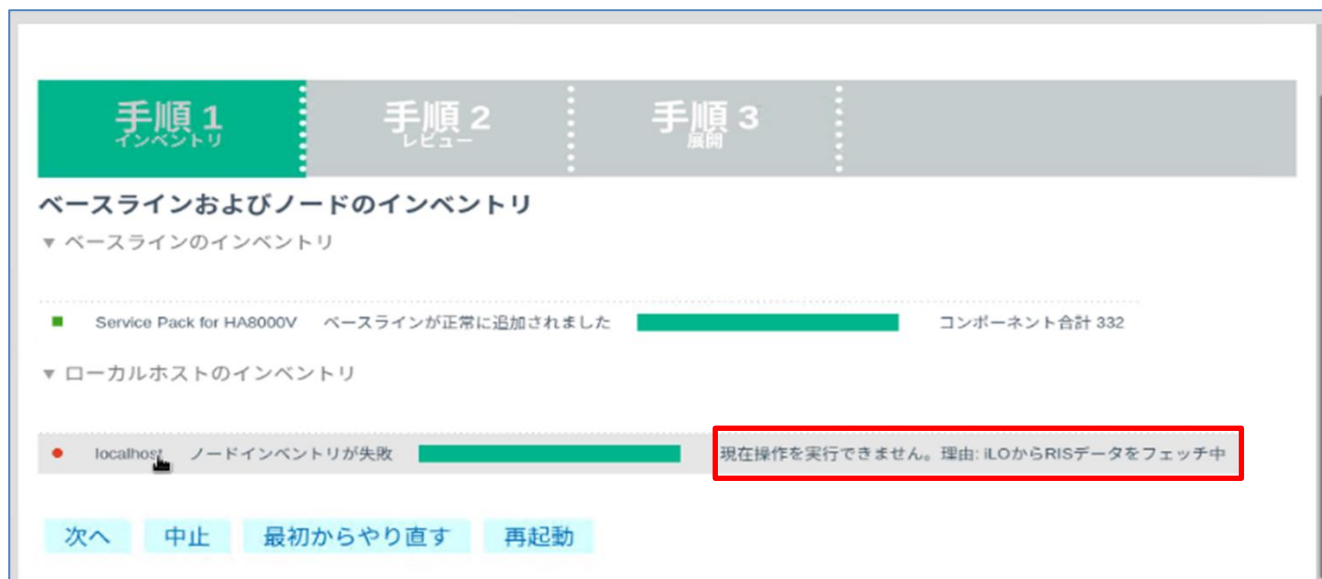
【インベントリ失敗時の表示例】

SUM は、アップデートに必要となるデバイスならびにソフトウェア等の情報を iLO 経由で取得します。iLO の状態により、まれに情報取得できないことがあり、以下に示すようにインベントリに失敗します。

SUM を再実行しても本エラーが解消されない場合は、下記のいずれかの手順を実施してください。

- (1) iLO の再起動（リセット）を実施してください。詳細は『iLO 6 x.xx ユーザーガイド』（※）の「iLO の再起動（リセット）」を参照してください。『iLO 6 x.xx ユーザーガイド』は、「[日立アドバンスドサーバー HA8000V シリーズ ホームページ](#)」に掲載されている「製品マニュアル」よりダウンロードしてください。
- (2) オンラインアップデート(OS 稼働中のアップデート)の場合、装置の再起動を実施してください。
- (3) 装置の給電を停止(電源ケーブルの抜去や UPS の出力停止等)後、10 秒待った後に給電を再開してください。
