**HA8000V シリーズ**

**Service Pack for HA8000V (SPH)**

**Version 7.45 32**

**Readme**

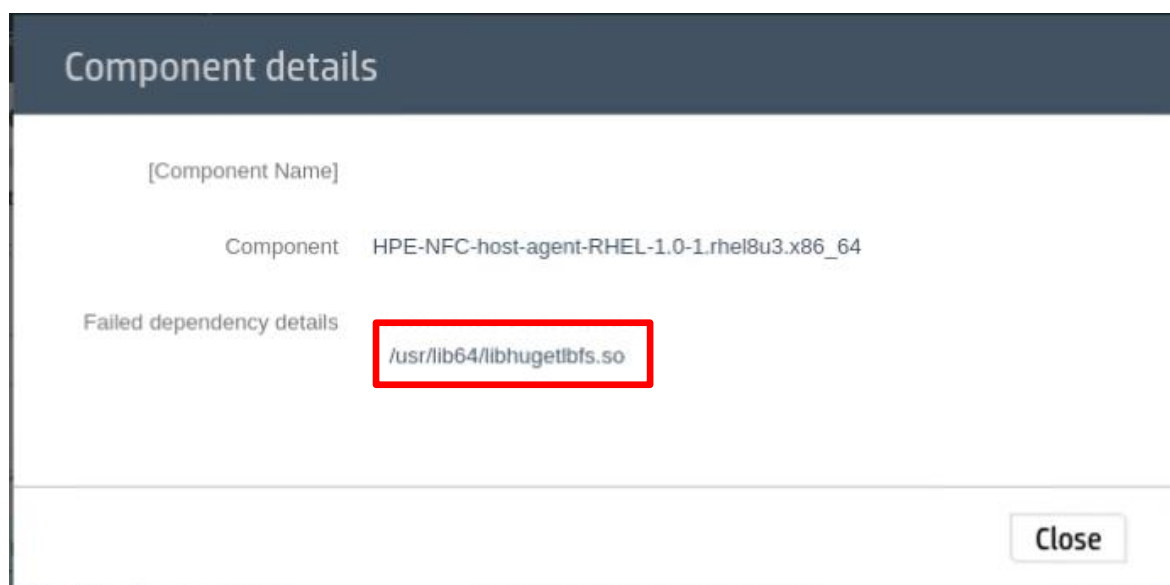
上記赤枠内の赤丸をダブルクリックすると次のダイアログが表示され、“Failed dependency details”として、インストールが必要となるファイル/ライブラリが表示されます。(赤枠内)

上記の例では、インストールが必要となるファイル/ライブラリとして、“libhugetlbfs.so”を示しています。
