**HA8000V シリーズ**

**Service Pack for HA8000V (SPH)**

**Version 7.40 12**

**Readme**

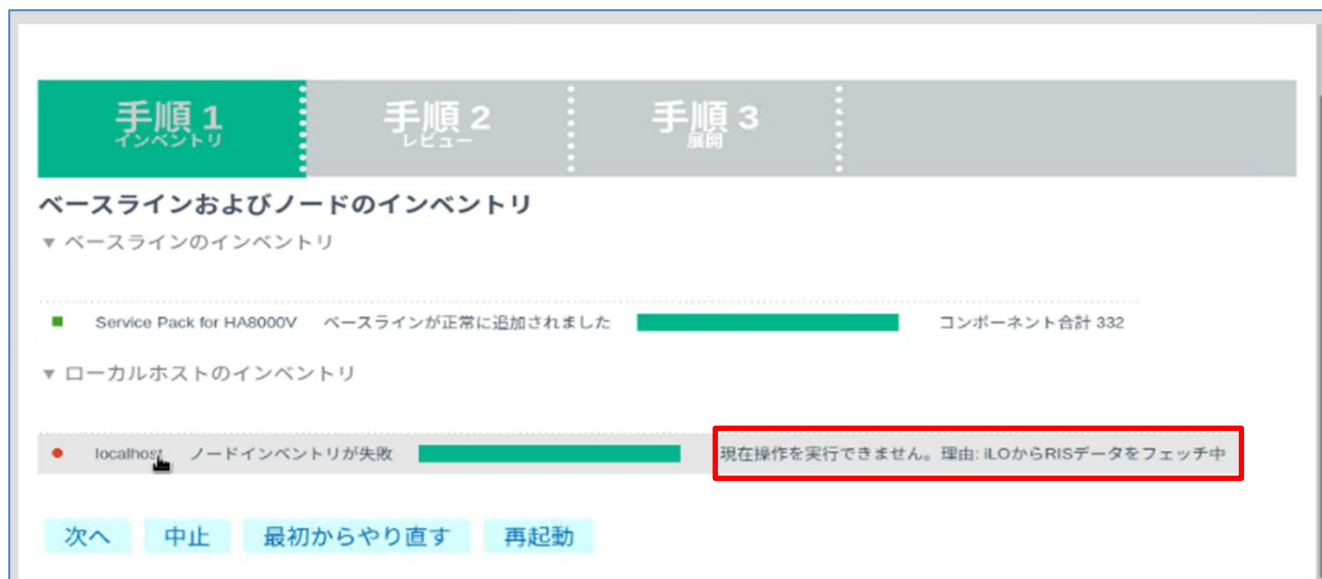
## 【インベントリ失敗時の表示例】

SUM は、アップデートに必要となるデバイスならびにソフトウェア等の情報を iLO 経由で取得します。iLO の状態により、まれに情報取得できないことがあり、以下に示すようにインベントリに失敗します。

SUM を再実行しても本エラーが解消されない場合は、下記のいずれかの手順を実施してください。

- (1) iLO の再起動（リセット）を実施してください。詳細は『iLO 6 x.xx ユーザーガイド』(※)の「iLO の再起動（リセット）」を参照してください。『iLO 6 x.xx ユーザーガイド』は、「[日立アドバンスドサーバー HA8000V シリーズ ホームページ](#)」に掲載されている「製品マニュアル」よりダウンロードしてください。
- (2) オンラインアップデート(OS 稼働中のアップデート)の場合、装置の再起動を実施してください。
- (3) 装置の給電を停止(電源ケーブルの抜去や UPS の出力停止等)後、10 秒待った後に給電を再開してください。
