**HA8000V シリーズ**

**Service Pack for HA8000V (SPH)**

**Version 7.45 32**

**Readme**

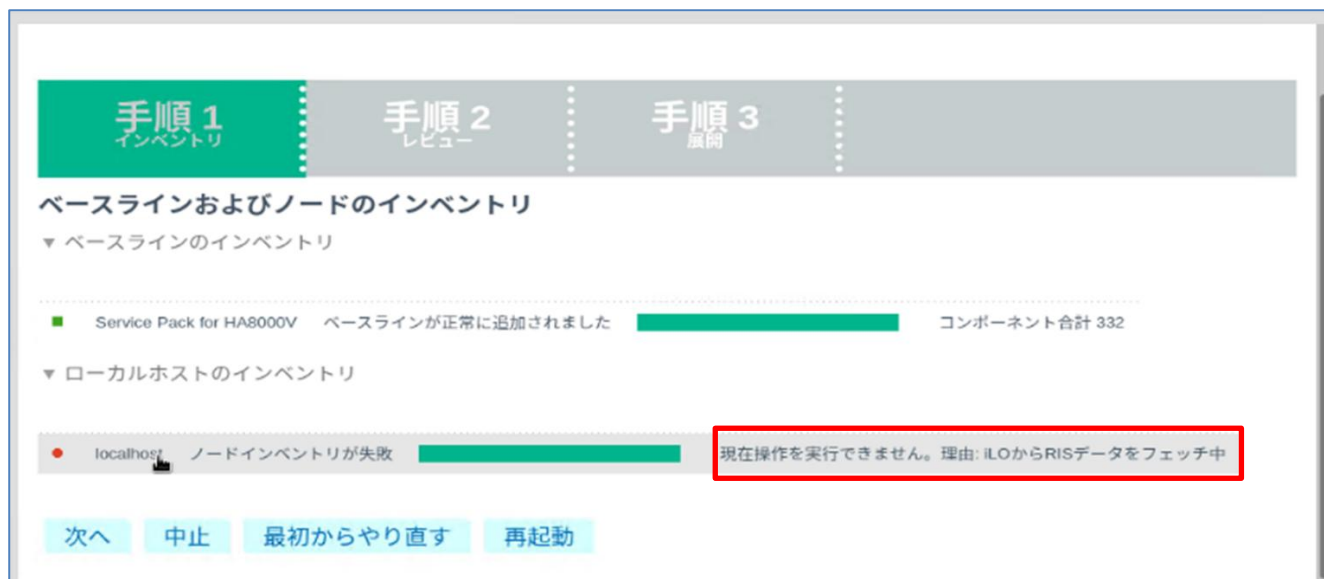
## 【インベントリ失敗時の表示例】

SUM を再実行しても本エラーが解消されない場合は、下記のいずれかの手順を実施してください。

- (1) iLO の再起動（リセット）を実施してください。詳細は『iLO 6 x.xx ユーザーガイド』(※)の「iLO の再起動（リセット）」を参照してください。『iLO 6 x.xx ユーザーガイド』は、「[日立アドバンスドサーバー HA8000V シリーズ ホームページ](#)」に掲載されている「製品マニュアル」よりダウンロードしてください。
- (2) オンラインアップデート(OS 稼働中のアップデート)の場合、装置の再起動を実施してください。
- (3) 装置の給電を停止(電源ケーブルの抜去や UPS の出力停止等)後、10 秒待った後に給電を再開してください。
