Service Pack for RV3000 (SPR)

Version 3.90 1

Readme

2. Service Pack for RV3000 (SPR)について

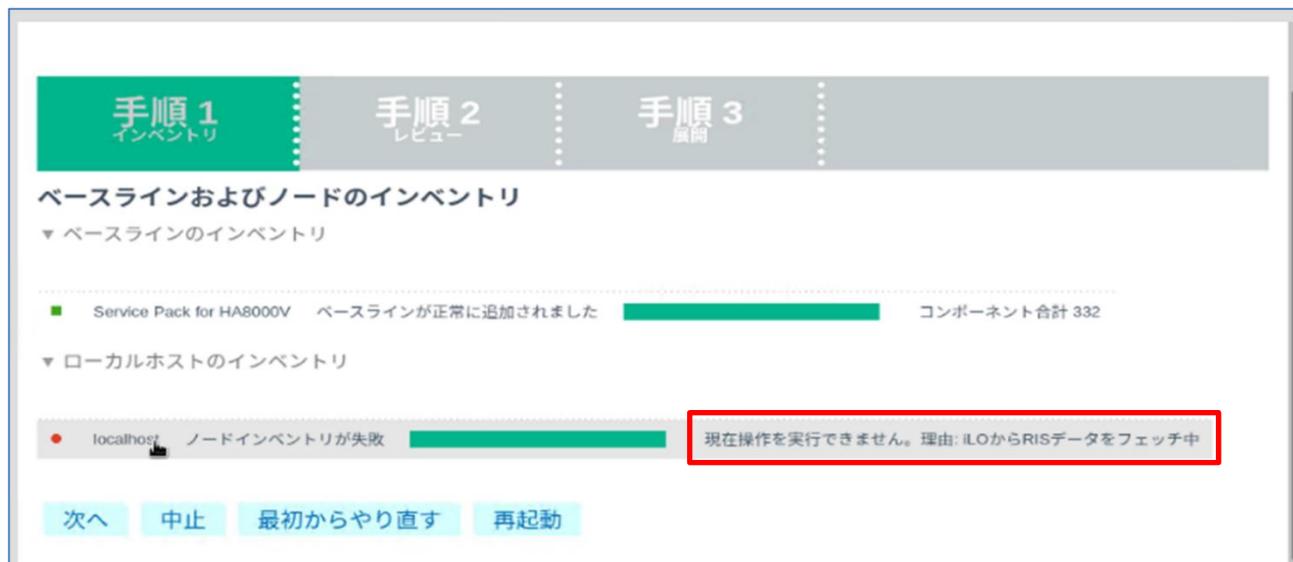
【インベントリ失敗時の表示例】

SUMは、アップデートに必要なデバイスならびにソフトウェア等の情報をiLO経由で取得します。iLOの状態により、まれに情報取得できないことがあり、以下に示すようにインベントリに失敗します。

SUMを再実行しても本エラーが解消されない場合は、下記のいずれかの手順を実施してください。

- (1) iLO の再起動（リセット）を実施してください。詳細は『iLO 5 x.xx ユーザーガイド』（※）の「iLO の再起動（リセット）」を参照してください。『iLO 5 x.xx ユーザーガイド』は、<https://www.hitachi.co.jp/rv3000/> に掲載されている「製品マニュアル」よりダウンロードしてください。
- (2) オンラインアップデート(OS 稼働中のアップデート)の場合、装置の再起動を実施してください。
- (3) 装置の給電を停止(電源ケーブルの抜去や UPS の出力停止等)後、10 秒待った後に給電を再開してください。
